## **STURGEON BAY SCHOOLS**

FACILITIES ASSESSMENT - APPENDIX

JULY 2019

EUA PROJECT NO. 318509

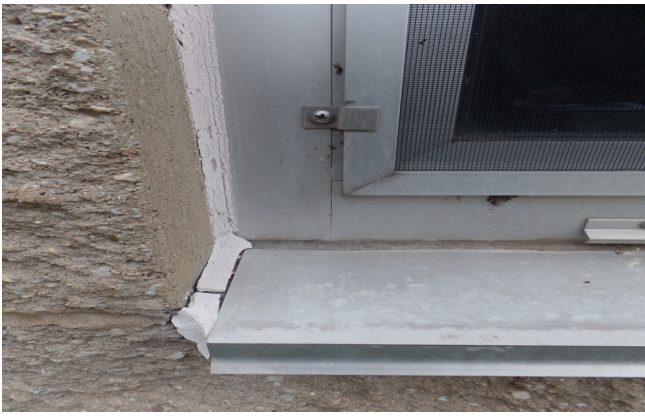
SAWYER - Window caulk / sealant failure

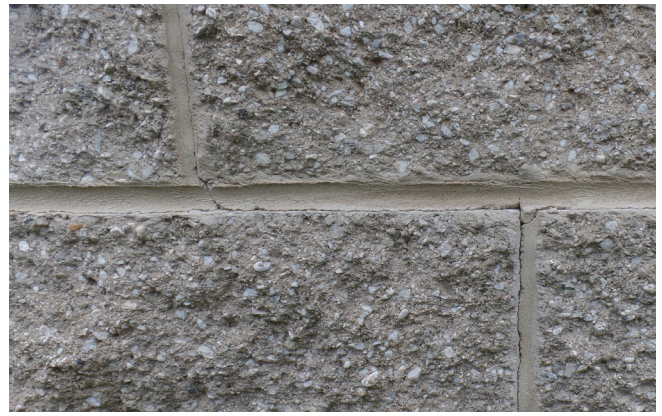
SAWYER - Cracked masonry mortar joint

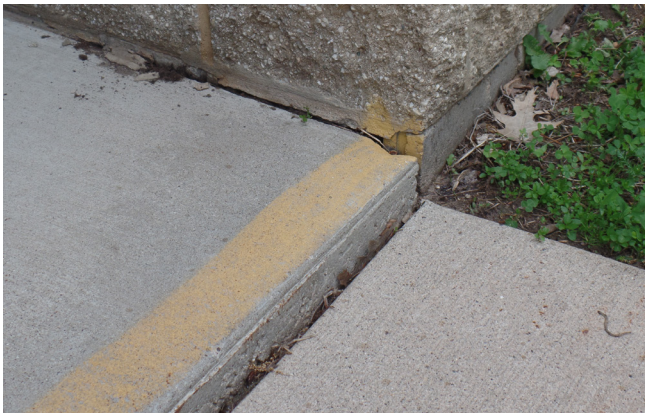
SAWYER - Door stoop / sidewalk settling trip hazard

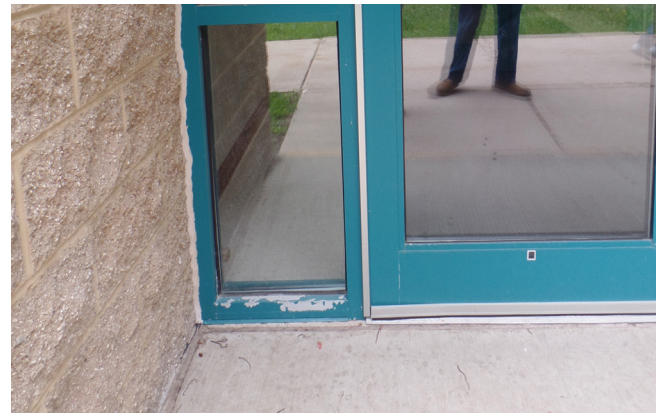
SAWYER - Door frame finish failing

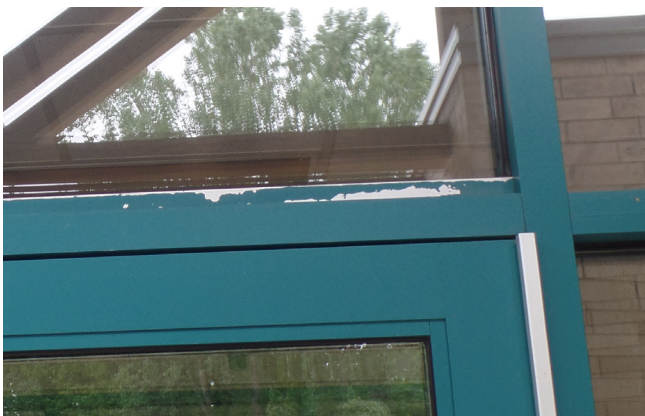
SAWYER - Door frame finish failing

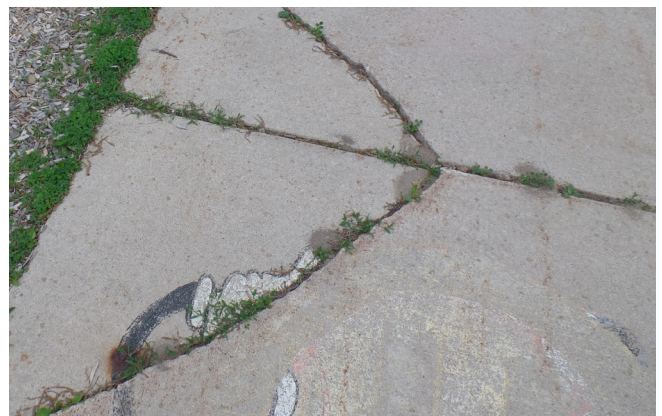
SAWYER - Cracked pavement / sidewalks

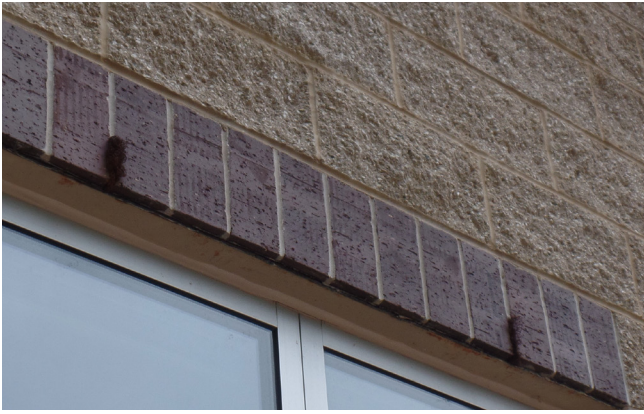
SAWYER - Incorrect masonry weeps / vents

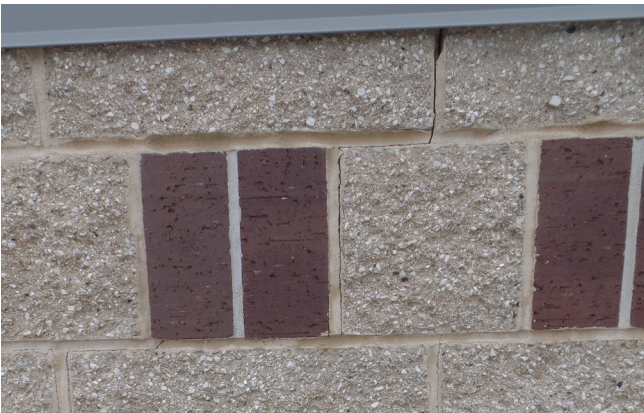
SAWYER - Cracked masonry at parapet

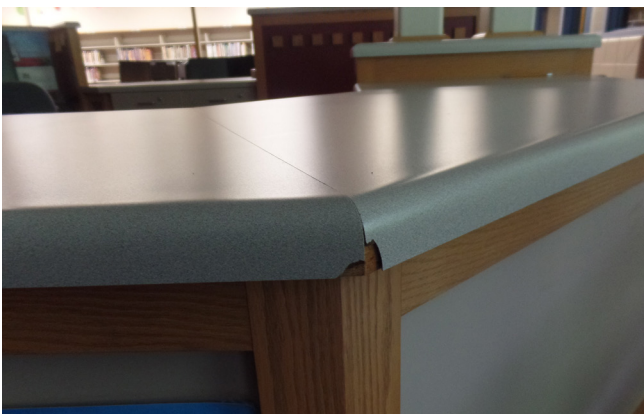
SAWYER - Millwork damage

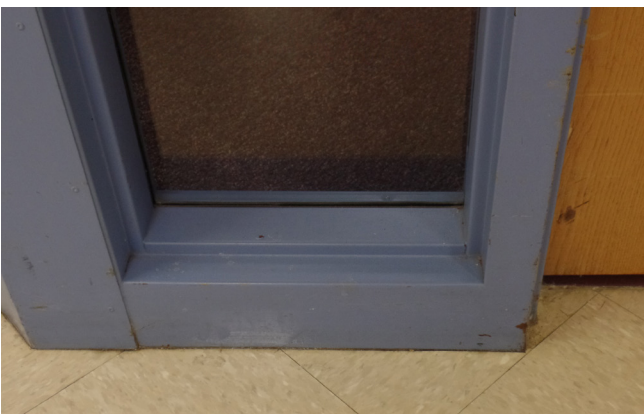
SAWYER - Finish showing wear on doors and frames

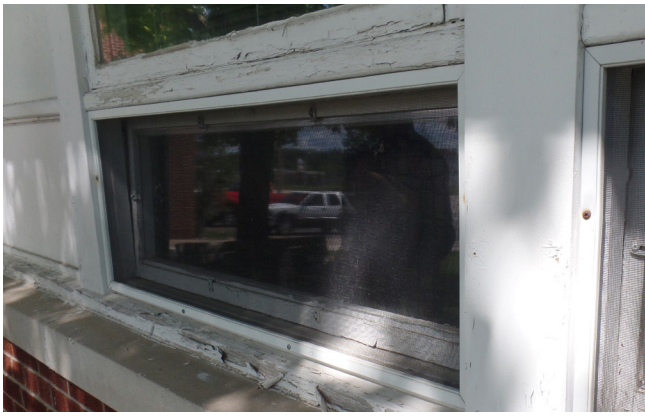
SUNRISE - Failing windows

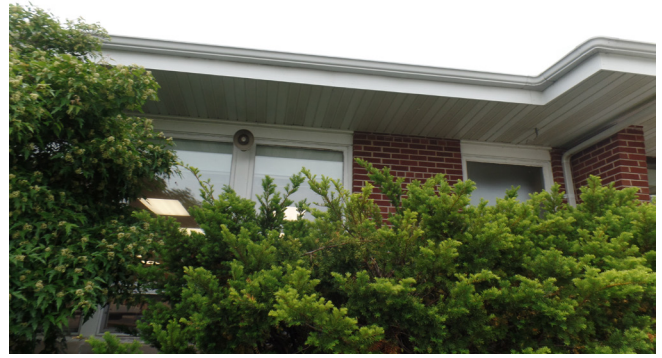
SUNRISE - Overgrown shrubs / trees

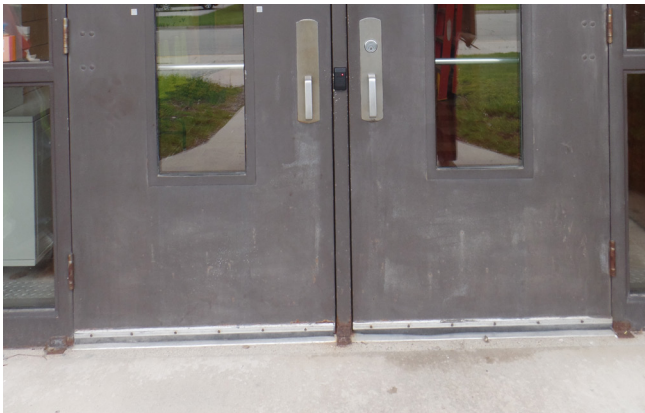
SUNRISE - Rusting / failing door frames

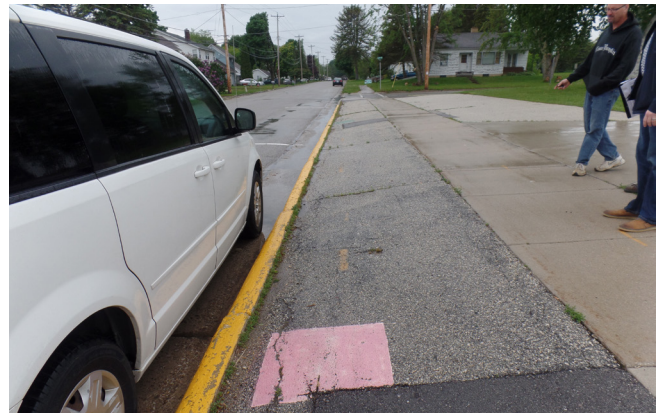
SUNRISE - Inaccessible (ADA) / unsafe pavement at student pickup / drop-off area

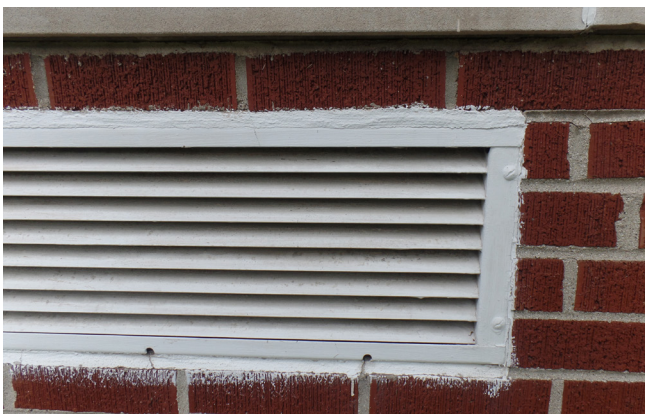
SUNRISE - Poorly fit / sealed louvers and vents

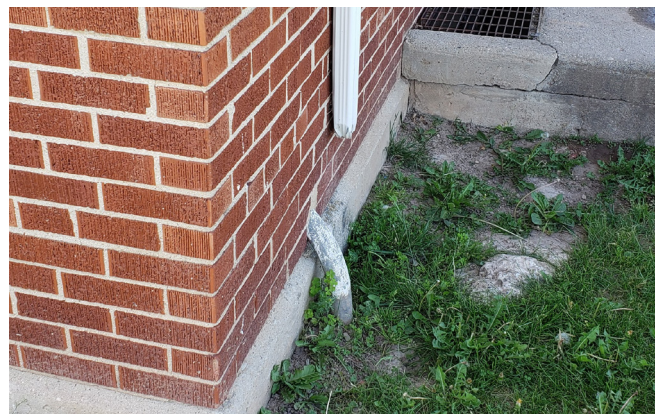
SUNRISE - Downspouts not connected/ improper site drainage

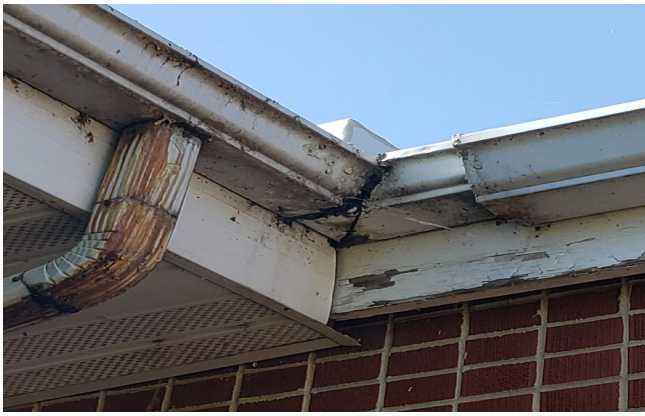
SUNRISE - Failing gutter / downspout / eaves

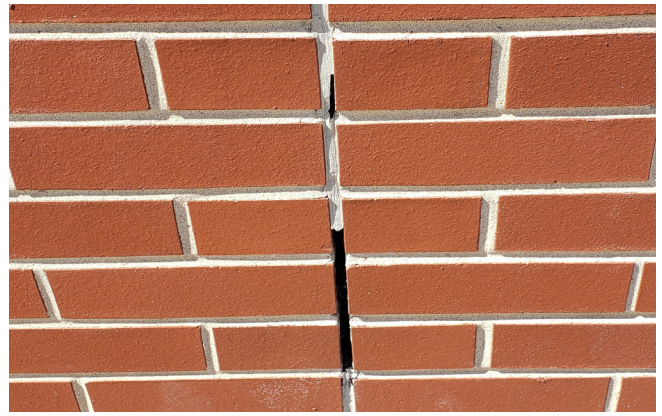
SUNRISE - Missing masonry mortar

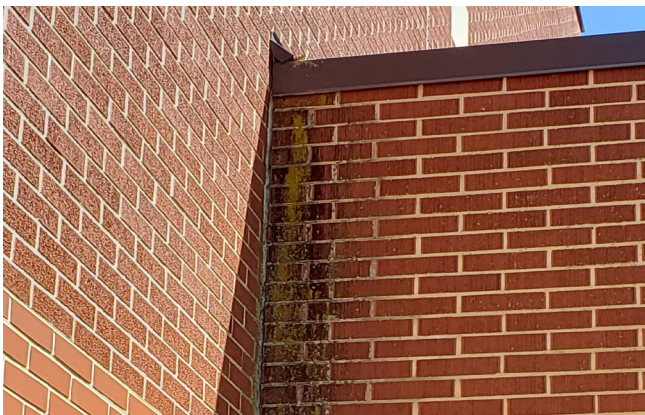
SUNRISE - Roof water damage to wall

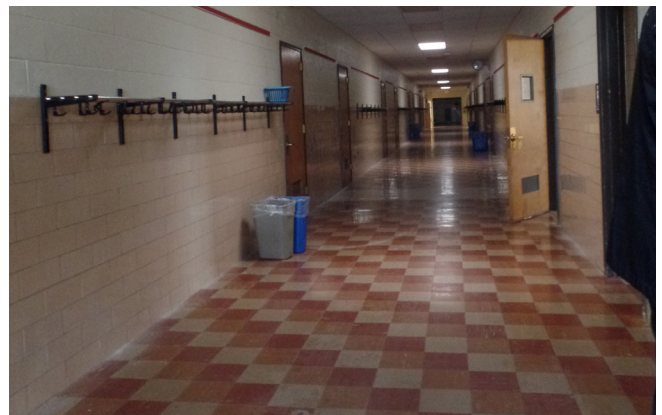
SUNRISE - Asbestos floor tile

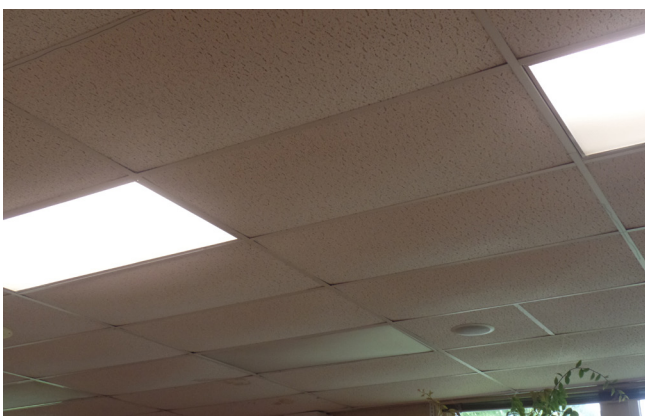
SUNRISE - Sagging ceiling tiles due to excessive humidity

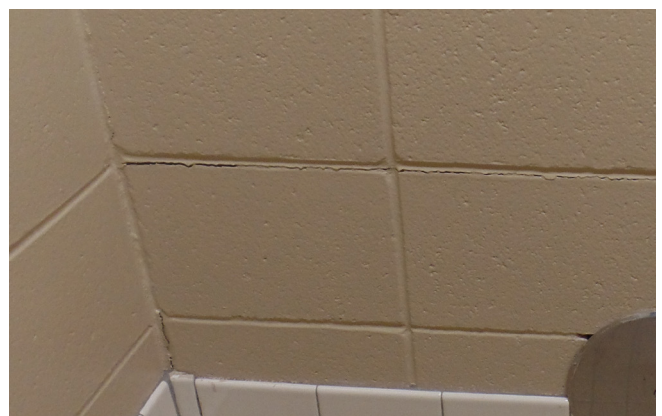
SUNRISE - Cracked masonry walls

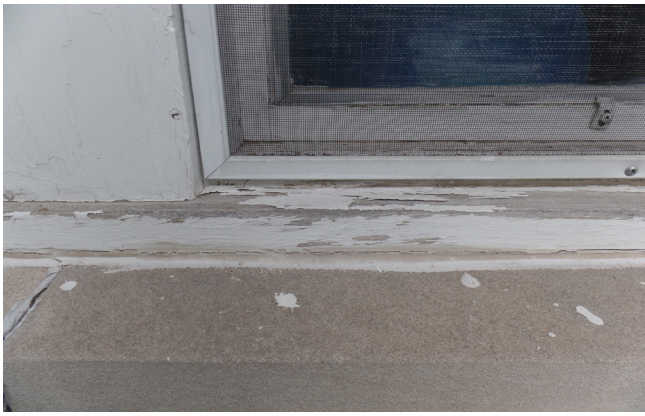
SUNSET - Failing / missing paint

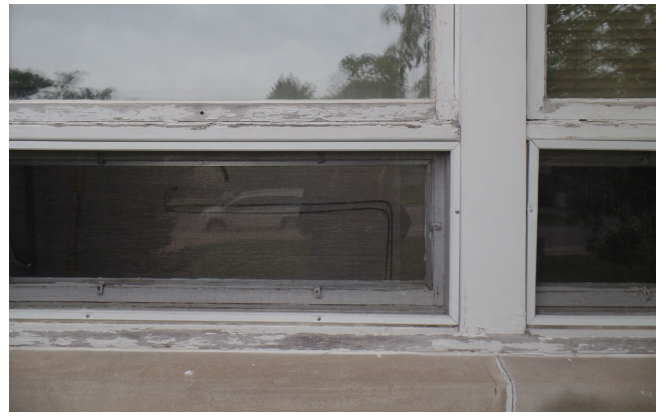
SUNSET - Failing windows

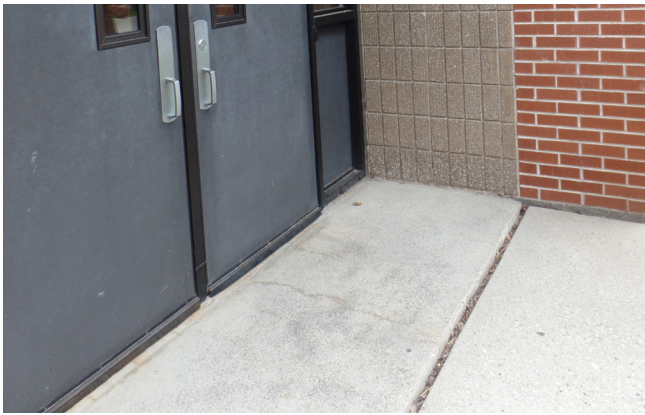
SUNSET - Stoop slab / sidewalk settling causing unsafe conditions.

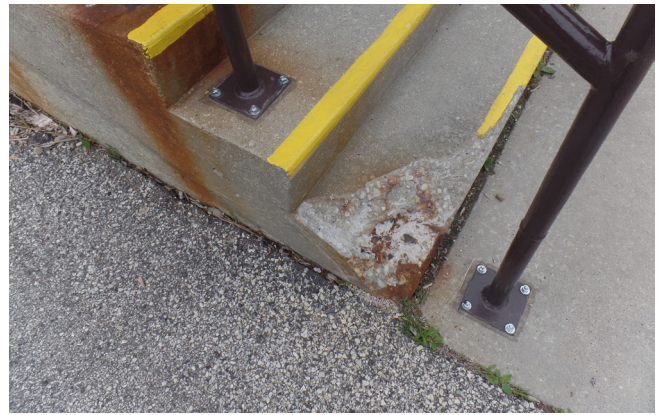
SUNSET - Deteriorating exterior concrete

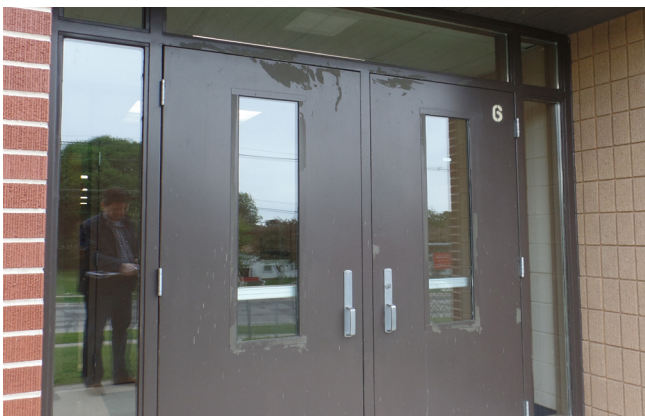
SUNSET - Door finish failing

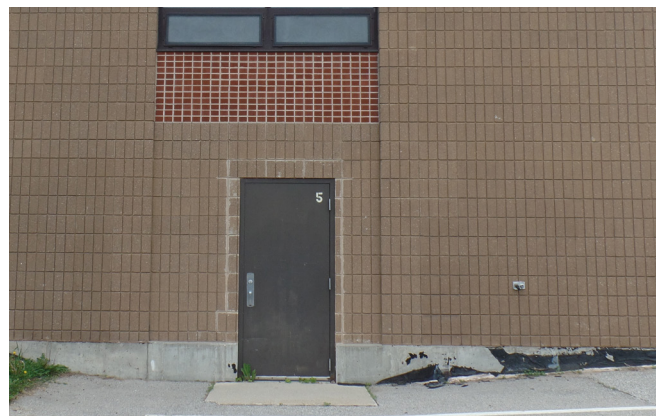
SUNSET - Improper grading, deteriorating waterproofing, failing sealants

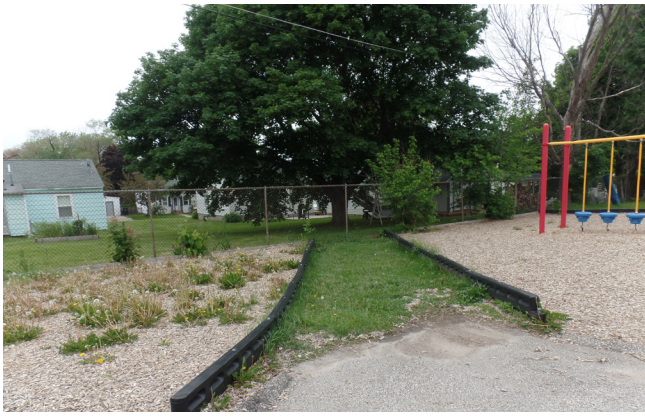
SUNSET - Poor site drainage

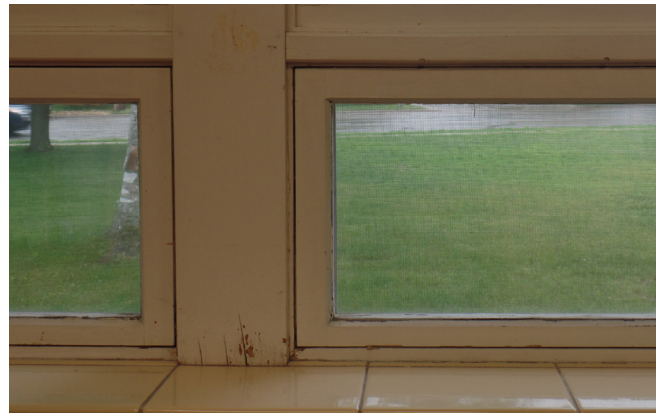
SUNSET - Failing windows

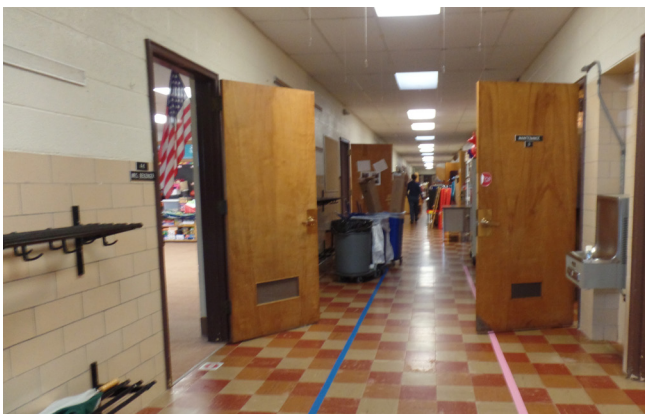
SUNSET - Asbestos floor tile

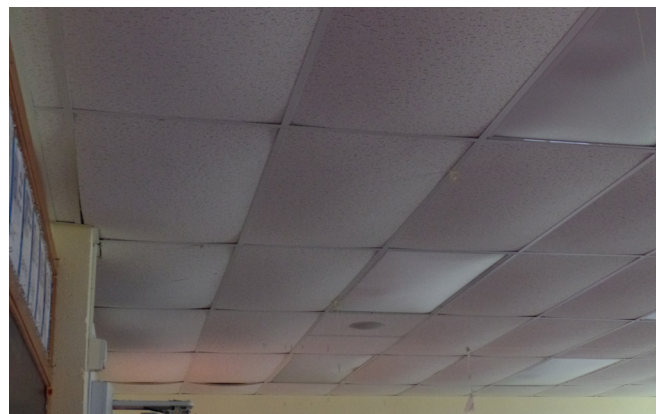
SUNSET - Ceiling tiles damaged / sagging due to high humidity

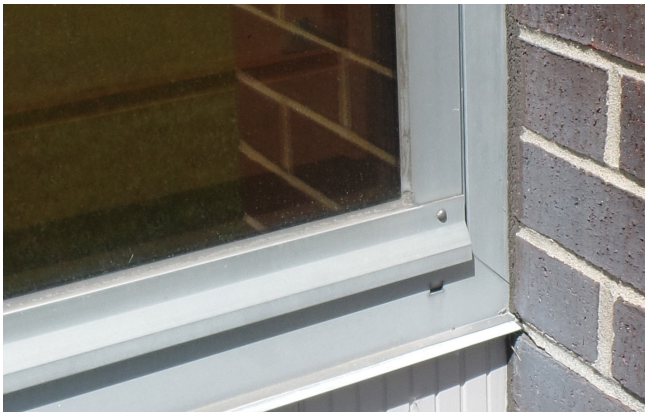
MIDDLE SCHOOL - Failing sealants at windows and louvers

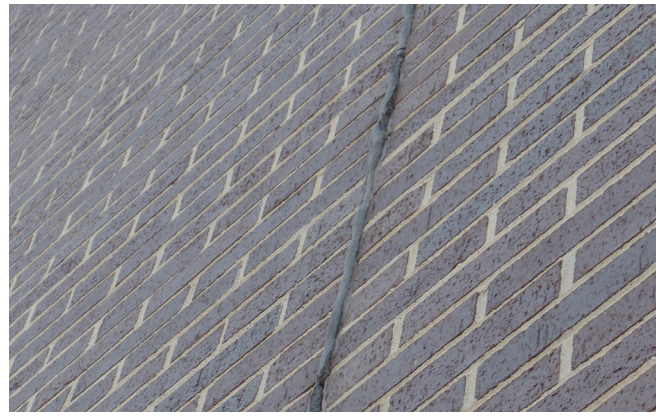
MIDDLE SCHOOL - Failing sealants at building control joints

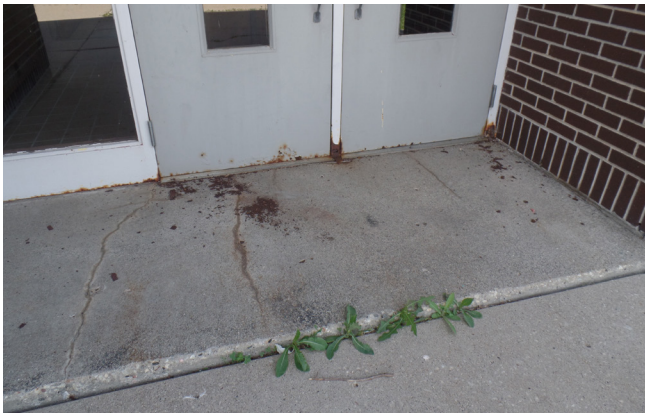
MIDDLE SCHOOL - Failing door / frame and uneven stoop / sidewalk slabs

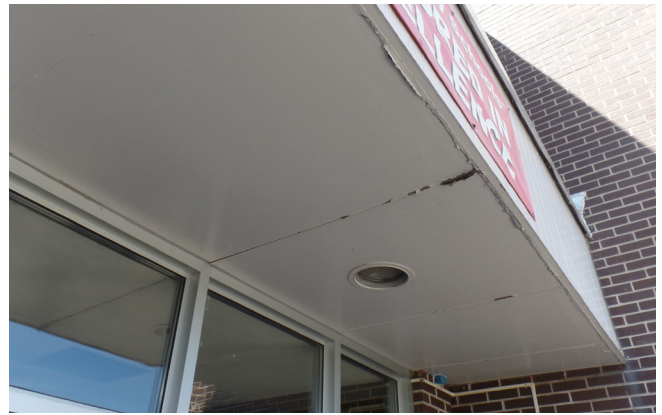
MIDDLE SCHOOL - Failing soffit / asbestos materials

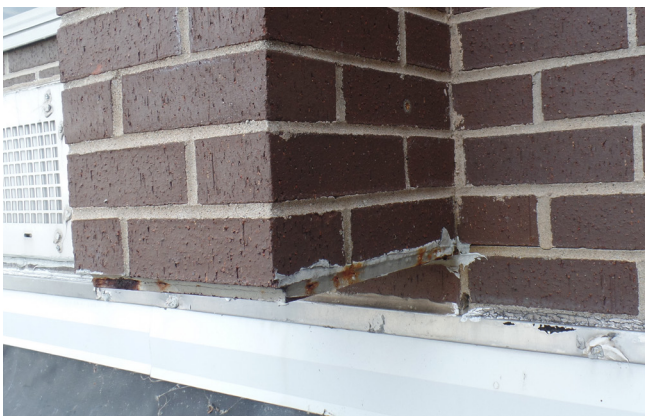
MIDDLE SCHOOL - Rusting masonry supports

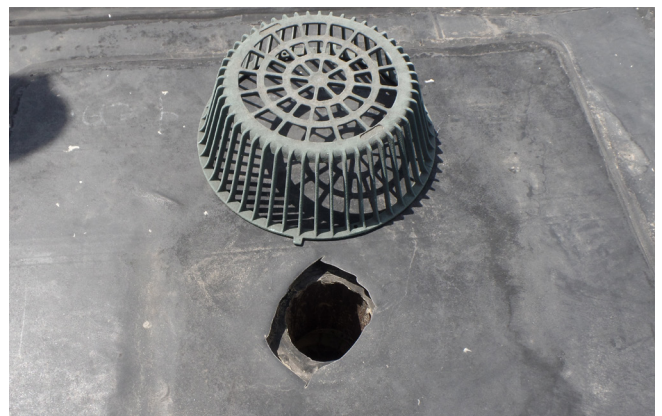
MIDDLE SCHOOL - Improper roof drain installation

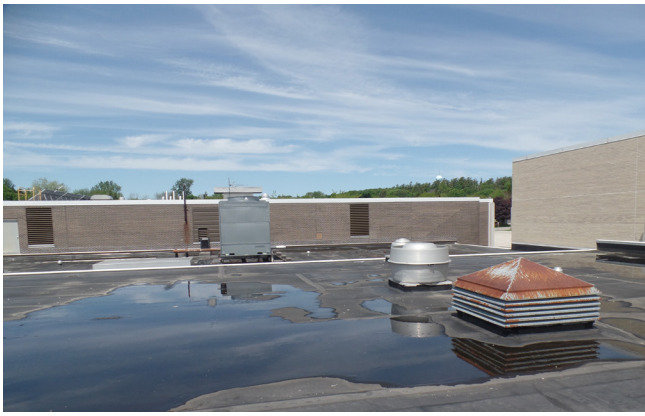
MIDDLE SCHOOL - Ponding water on roof / rusting roof vents

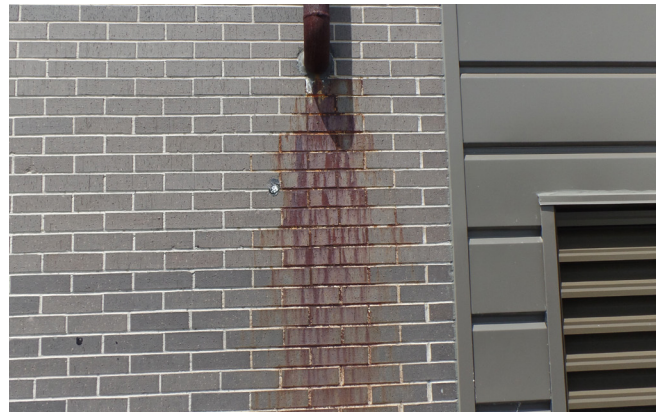
MIDDLE SCHOOL - Penetrations through wall rusting and staining masonry

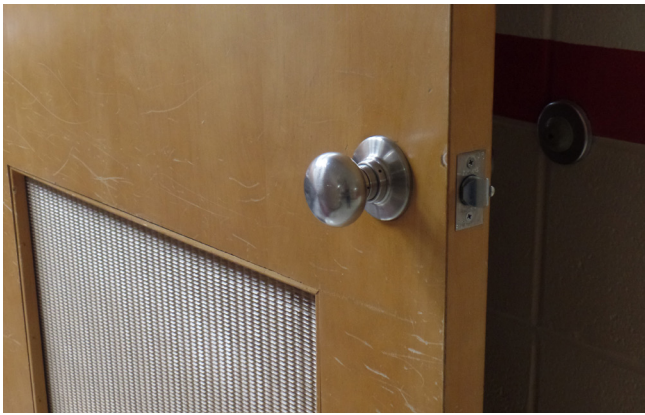
MIDDLE SCHOOL - Inaccessible door hardware (ADA)

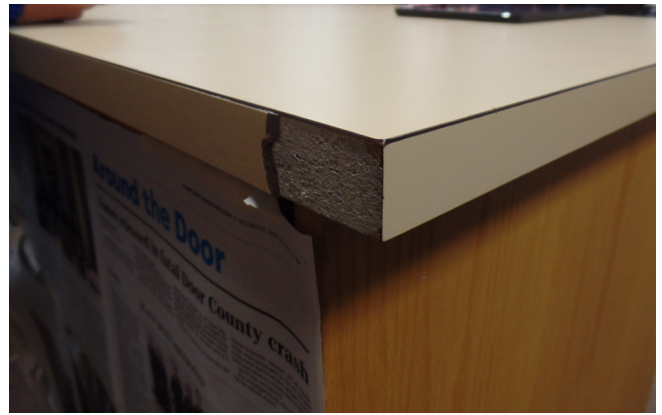
MIDDLE SCHOOL - Millwork showing signs of wear

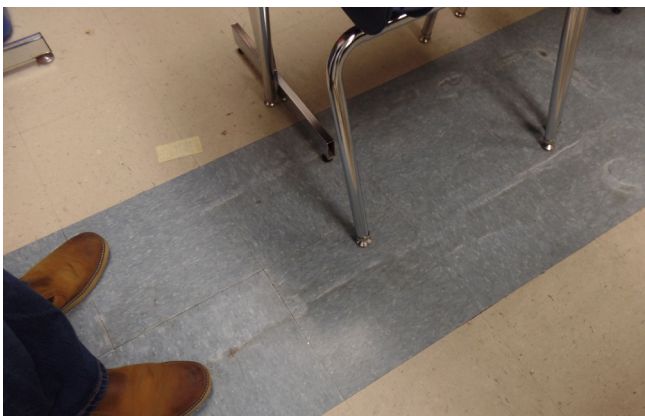
MIDDLE SCHOOL - Flooring failing / peeling away from concrete

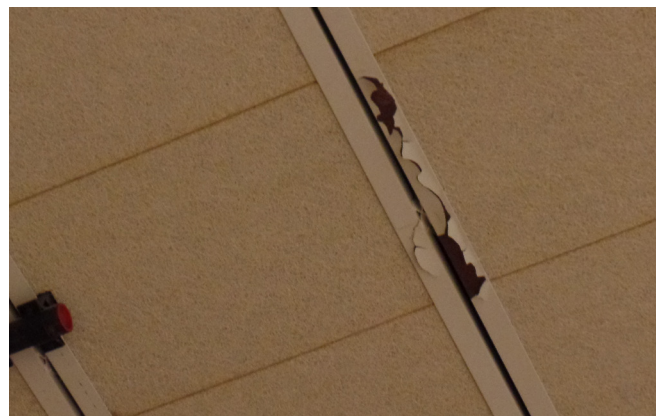
MIDDLE SCHOOL - Rusting / failing paint on ceiling beams in gym

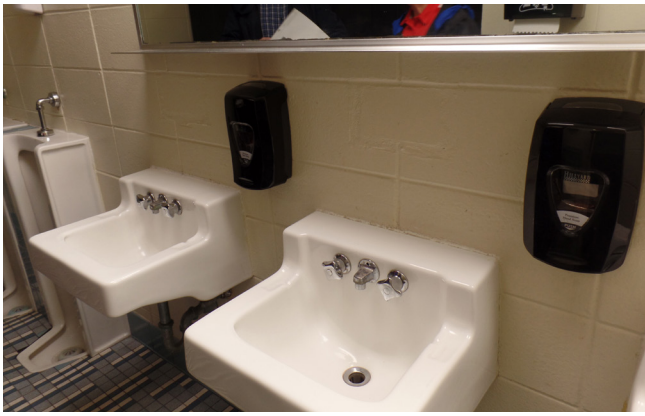
MIDDLE SCHOOL - Inaccessible (ADA) restroom fixtures and accessories

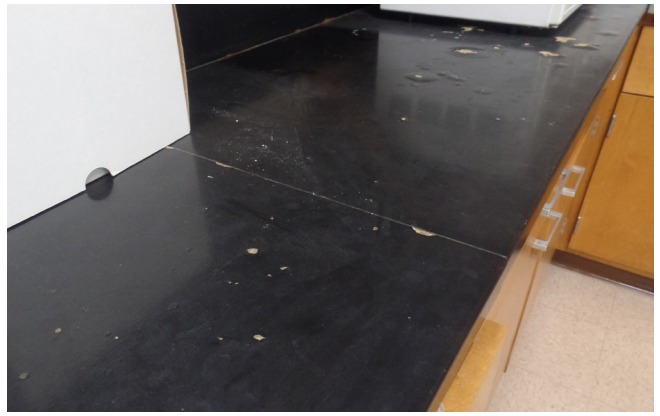
MIDDLE SCHOOL - Damaged millwork / counter-top

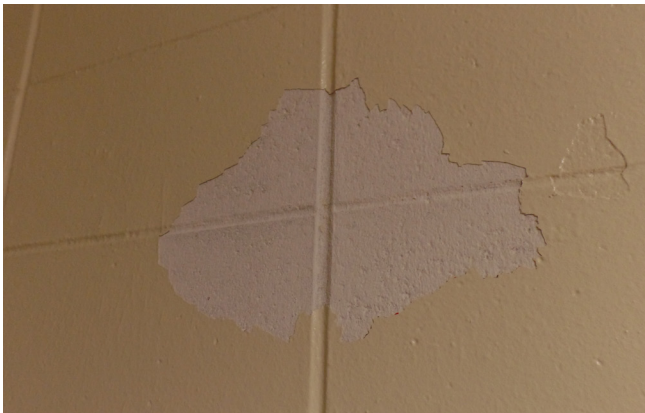
MIDDLE SCHOOL - Peeling paint on walls

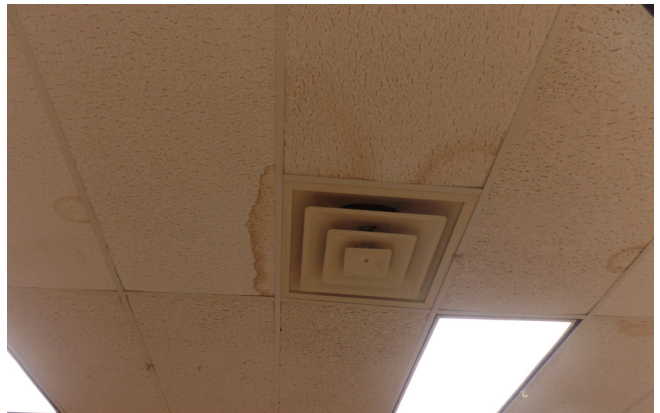
MIDDLE SCHOOL - Stained ceiling tiles

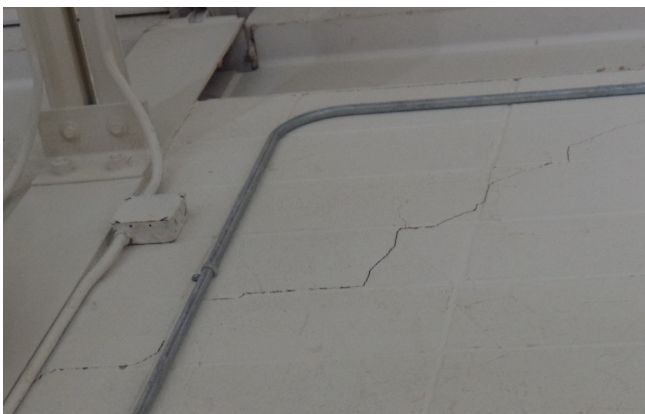
HIGH SCHOOL - Cracked block wall

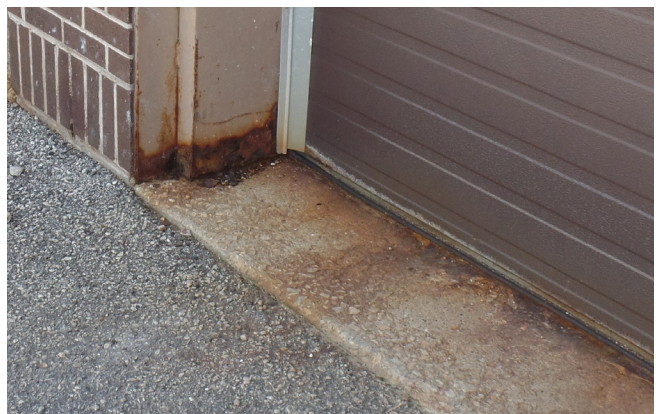
HIGH SCHOOL - Rusting door frames

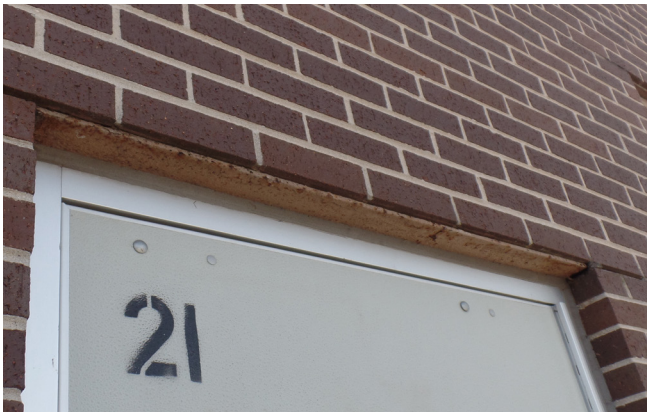
HIGH SCHOOL - Rusting masonry lintels

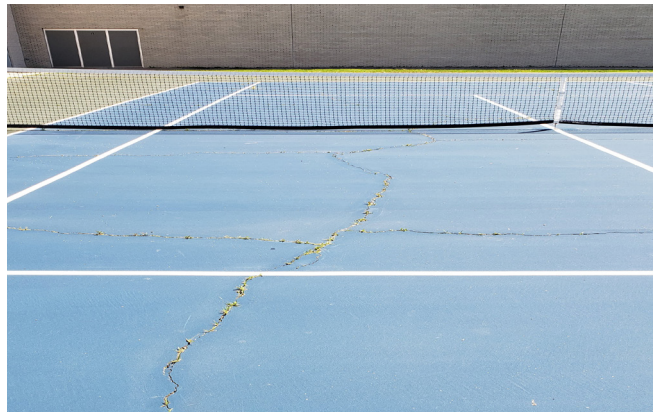
HIGH SCHOOL - Tennis court pavement cracked and failing

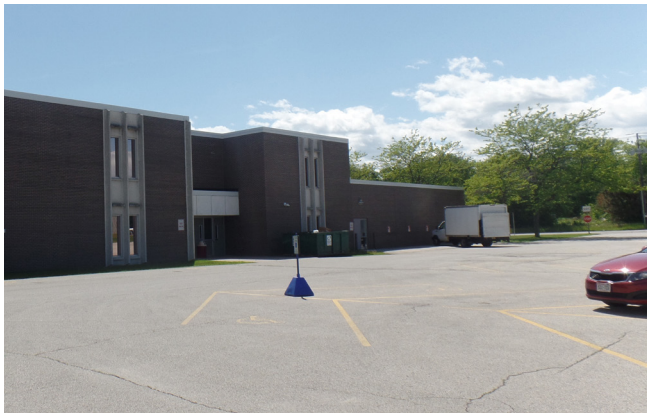
HIGH SCHOOL - Accessible (ADA) parking and loading zone not properly marked / identified

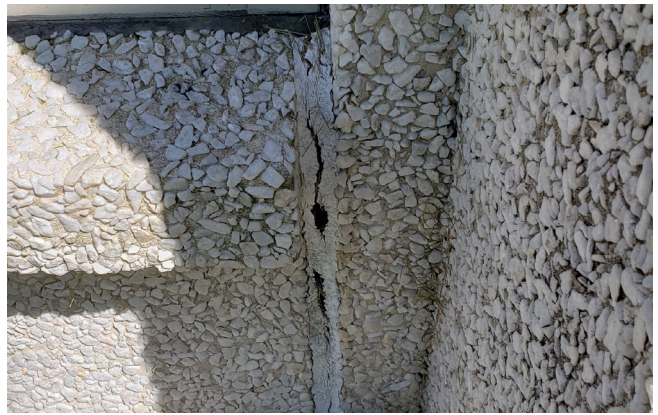
HIGH SCHOOL - Failing sealant joints

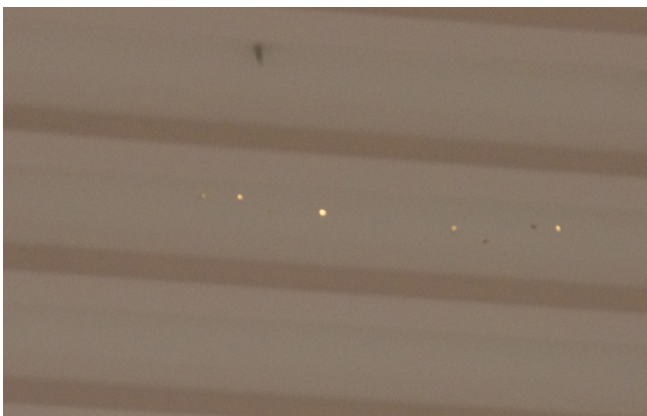
HIGH SCHOOL - Random holes in roof deck at wrestling / work out room

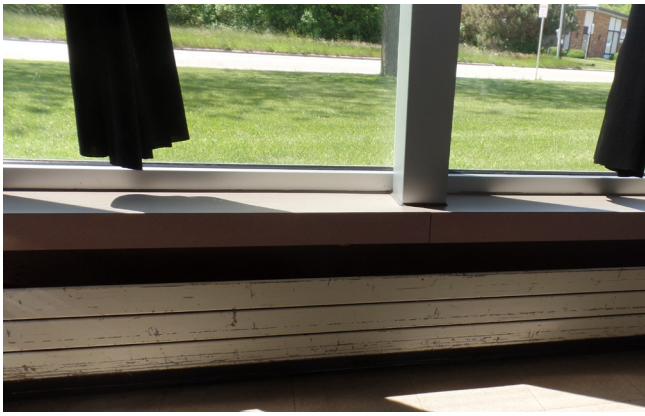
HIGH SCHOOL - Radiators showing signs of wear

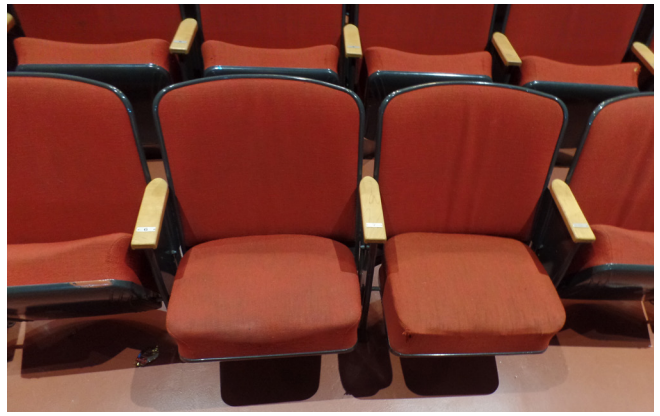
HIGH SCHOOL - Auditorium seating showing wear

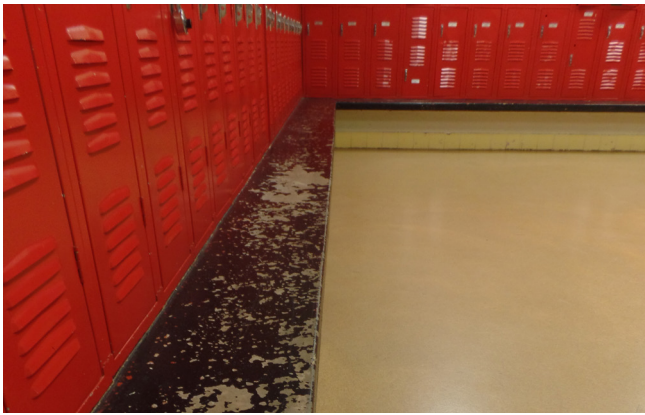
HIGH SCHOOL - Locker room equipment, lockers and flooring showing wear / failing.

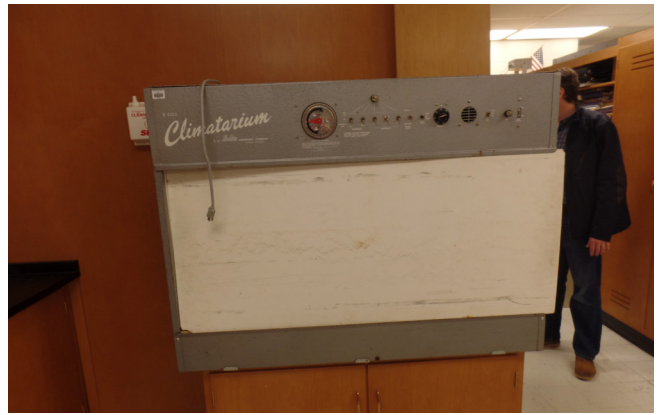
HIGH SCHOOL - Outdated laboratory equipment

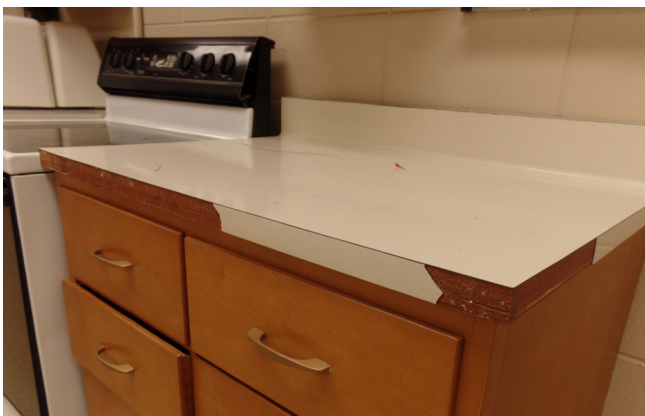
HIGH SCHOOL - Millwork failing / showing wear

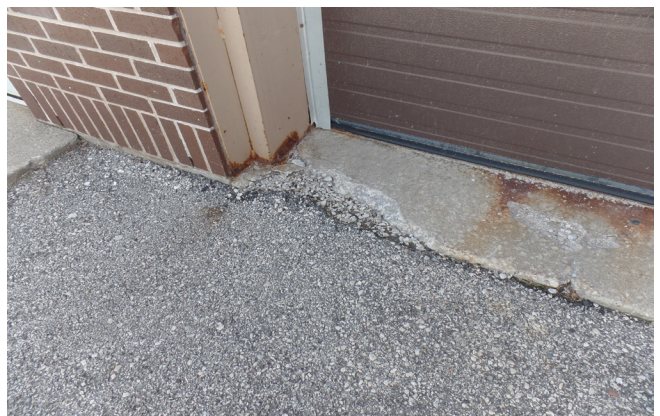
HIGH SCHOOL - Concrete failing
