## **STURGEON BAY SCHOOLS**

FACILITIES ASSESSMENT - APPENDIX

JULY 2019

EUA PROJECT NO. 318509

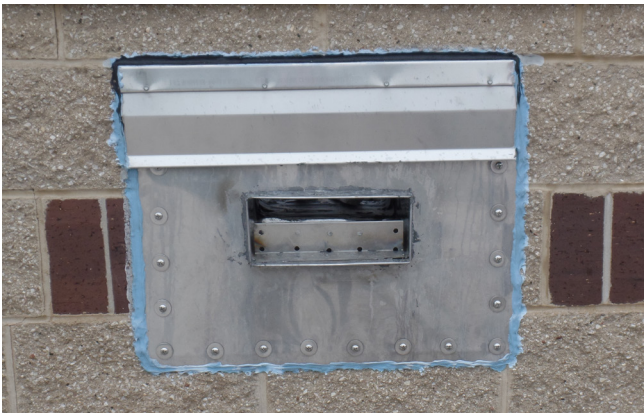
SAWYER - Poor scupper patch at parapet

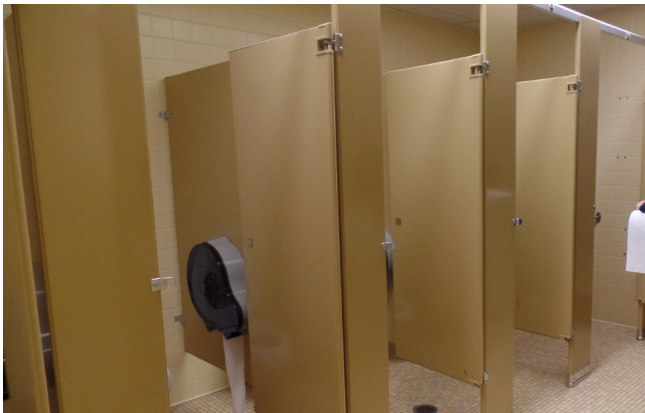
SUNSET - Inaccessible restrooms (ADA)

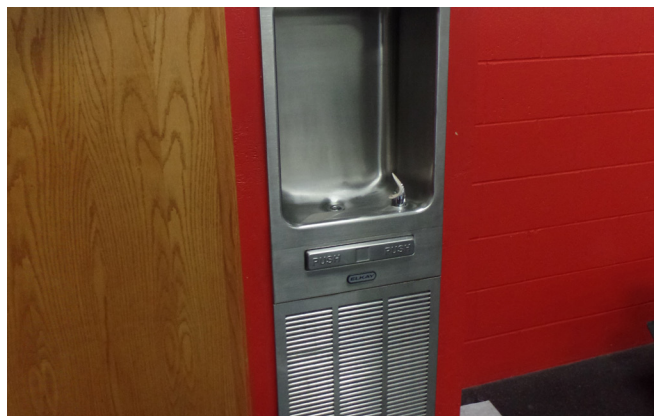
HIGH SCHOOL - Inaccessible drinking fountain (ADA)
