## **STURGEON BAY SCHOOLS**

FACILITIES ASSESSMENT - APPENDIX

JULY 2019

EUA PROJECT NO. 318509

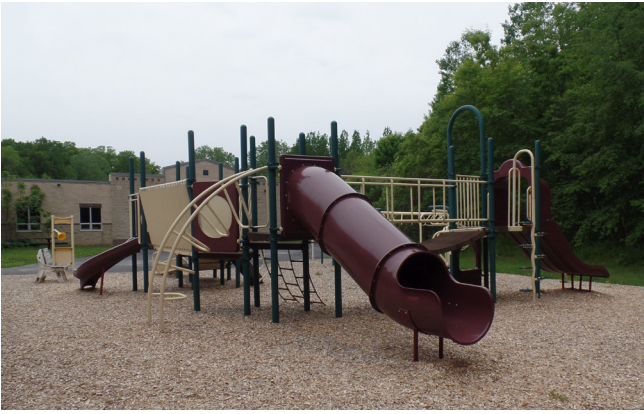
SAWYER - Inaccessible play area (ADA)

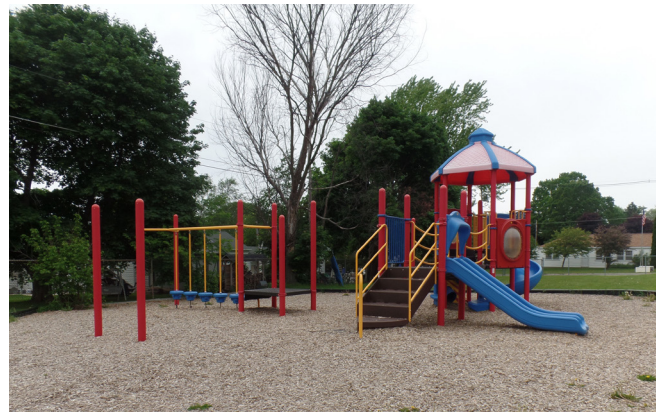
SUNSET - Inaccessible playground / play area (ADA)
